**RE: PROPOSED LEP LISTING OF 63-67 PIPERS FLAT ROAD WALLERAWANG
NSW 2845 AS LOCAL HERITAGE ITEM**

Attachment - Heritage Assessment: Fish River Water Supply Scheme

Executive Summary

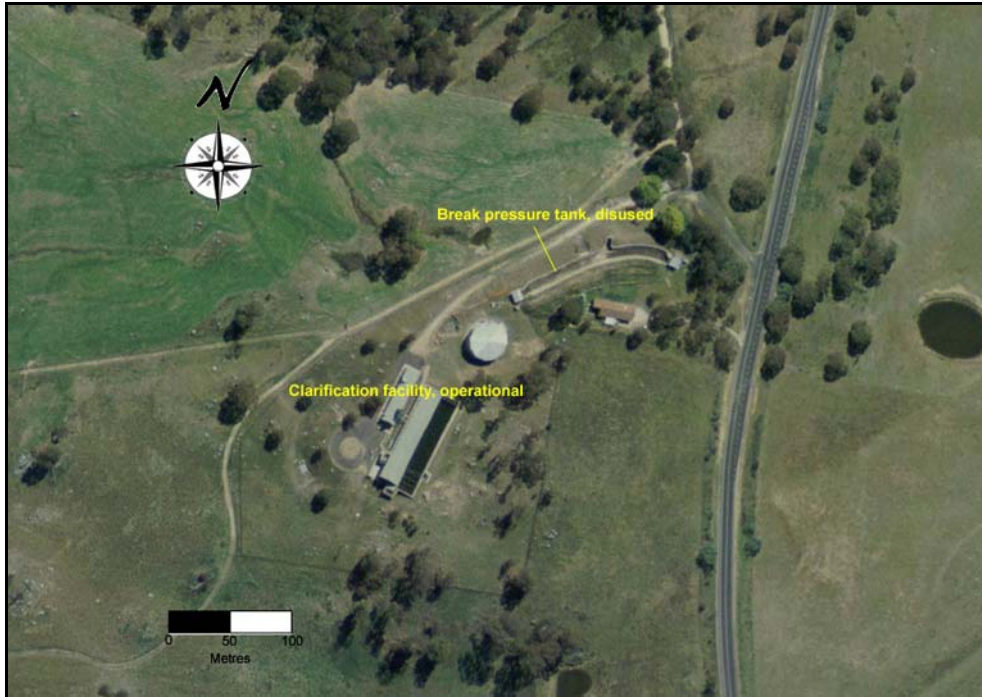
Figure 5: Duckmaloi water treatment plant and break pressure tank (Source: Department of Lands)

The break pressure tank at the Duckmaloi Water Treatment Plant is a crescent shaped concrete channel with inlet pipes at each end and a central screening chamber outlet (**Figure 5**). The channel is approximately 150 m in length and is trapezium shaped in section (**Plates 18–20**). Access to the floor of the channel is available at the southern end via concrete steps located on the eastern side of the channel.

Flows were drawn from Oberon Dam at one end, and Duckmaloi Weir at the other. Two float controlled Larner-Johnson needle valves regulated flows at either end. Pressure surges, or 'water hammer', were prevented by damping the action of the floats.

The break pressure tank at Duckmaloi was constructed in order to allow flows from Oberon Dam and Duckmaloi Weir to be used singly or in combination. It was built during Stage Two in advance of the construction of Duckmaloi Weir itself (Stage Three).

The overall condition of the break pressure tank is good. The original fabric of the Duckmaloi break pressure tank is intact and in good condition. No intrusive elements, other than vegetation, are present. Fittings, such as the screening chamber grill, are extant. The northern floor of the concrete channel is dominated by reeds (**Plate 19**), however, the southern end of the channel is relatively clear of vegetation. Water and sediment were present in the screening chamber outlet on the day of the study (**Plate 20**).

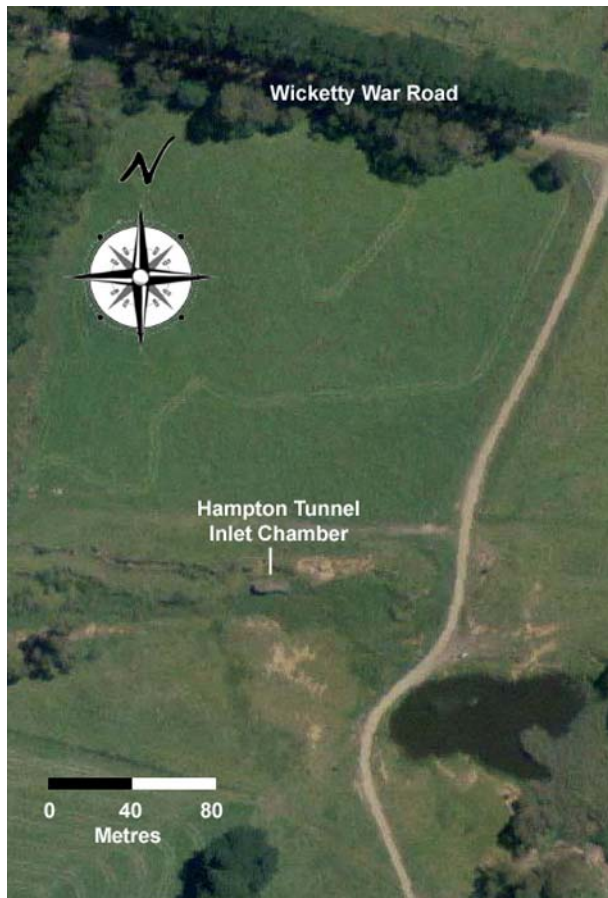
Figure 7: Detail of Hampton Tunnel inlet chamber (Source: Department of Lands)

east-west axis (**Figures 6–7** and **Plates 21–23**). Access is via a door at the western end of the building and an opaque green metal window can be opened on the southern wall. A peaked metal skylight on the roof can be opened to provide light. The hut provides access to the Hampton Tunnel pipeline via a rung ladder and contains a float controlled needle valve.

The building's condition is fair. Concrete rot is evident and the lower door hinge is broken (**Plate 23**). All other fittings are intact. The working parts and building fabric of the Hampton Tunnel inlet chamber are intact and largely original (with the exception of the additions of electrical components and solar panel). The condition of the original building fabric is fair and some components (e.g. door hinge) are in need of replacement.

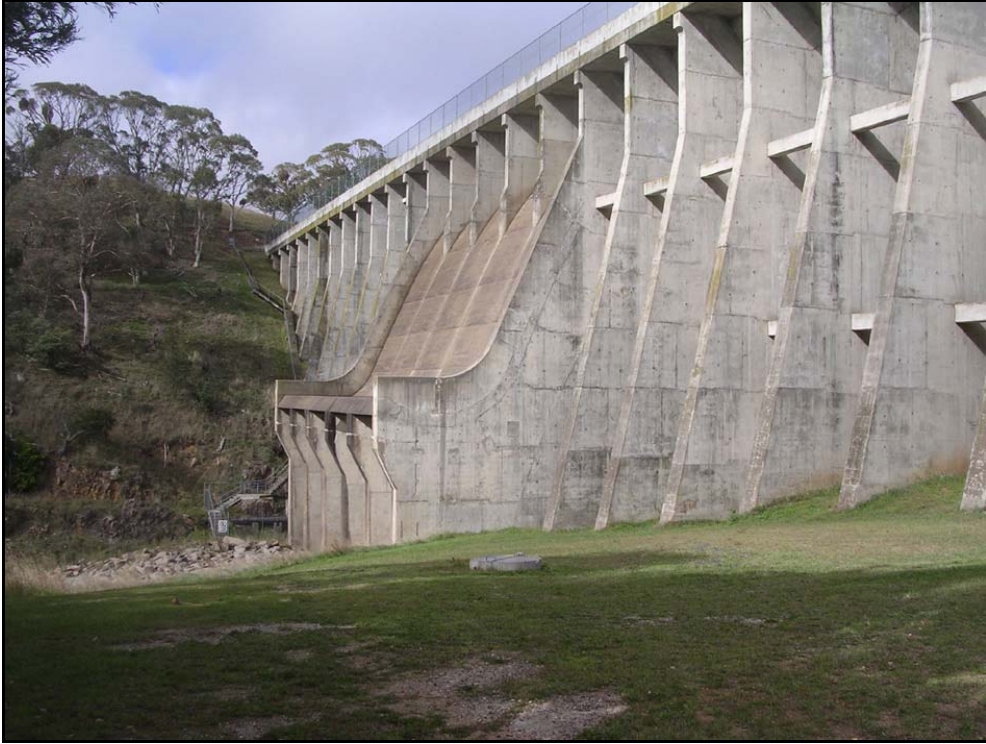
The five bay ski-jump spillway is of concrete construction and is in good condition (**Plate 1**). The spillway is 27 m in length with a radius of 4.5 m. The Top Water Level is 1067 m and the lip stands at a height of 14 m above the stream bed. The control tower, which is of concrete construction, is accessed from the top of the dam wall via a foot bridge. The control tower contains electric lifting equipment (capable of lifting 1.25 T).

Plate 1: Oberon Dam, showing dam wall buttresses and ski-jump spillway. View is from west.

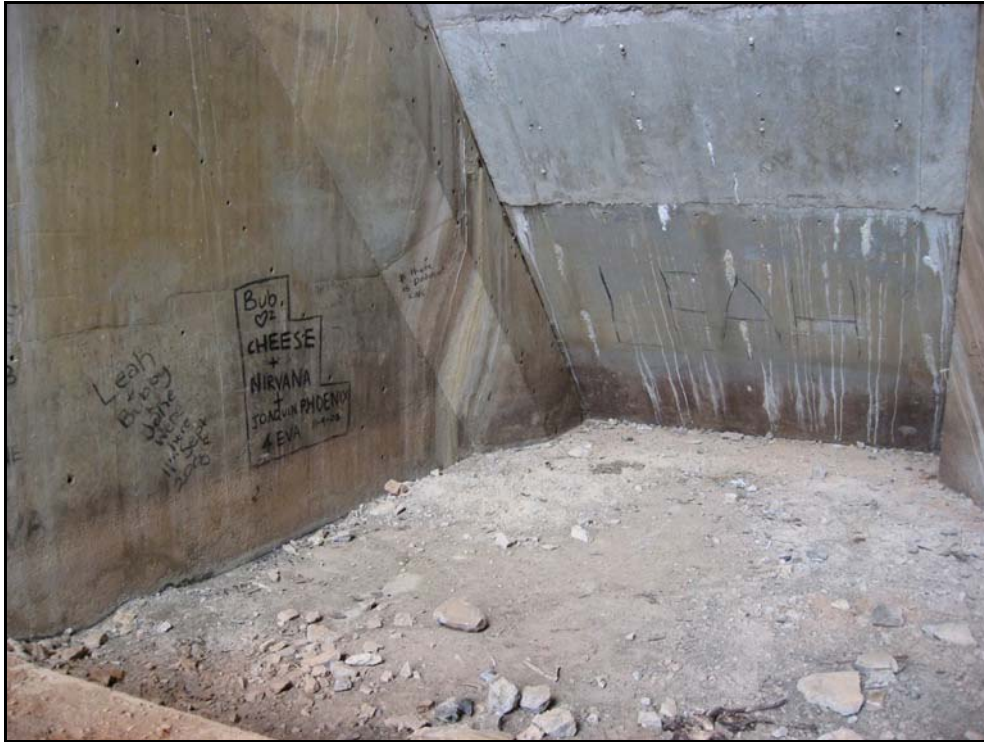
Oberon Dam is in good condition. Some graffiti has defaced the lower sections of concrete between buttresses (**Plates 3–4**), however, this has not damaged the overall fabric of the dam. As a rare/representative example of slab and buttress concrete dam construction, Oberon Dam has much potential for future archaeological research into public works and engineering in NSW. The Dam, as a historical place, is essentially intact. The original 1940s Stage One fabric remains *in situ*, as does the additional Stage Two fabric added during the 1950s. Minor alterations have been made in recent decades to the dam in order to improve safety (fencing along the top of the dam wall – **Plate 2**) and dam site logistics (corrugated iron doors converting a number of buttresses to storage areas).

Plate 3: Oberon Dam, showing detail of graffiti within buttress area. View is from north.

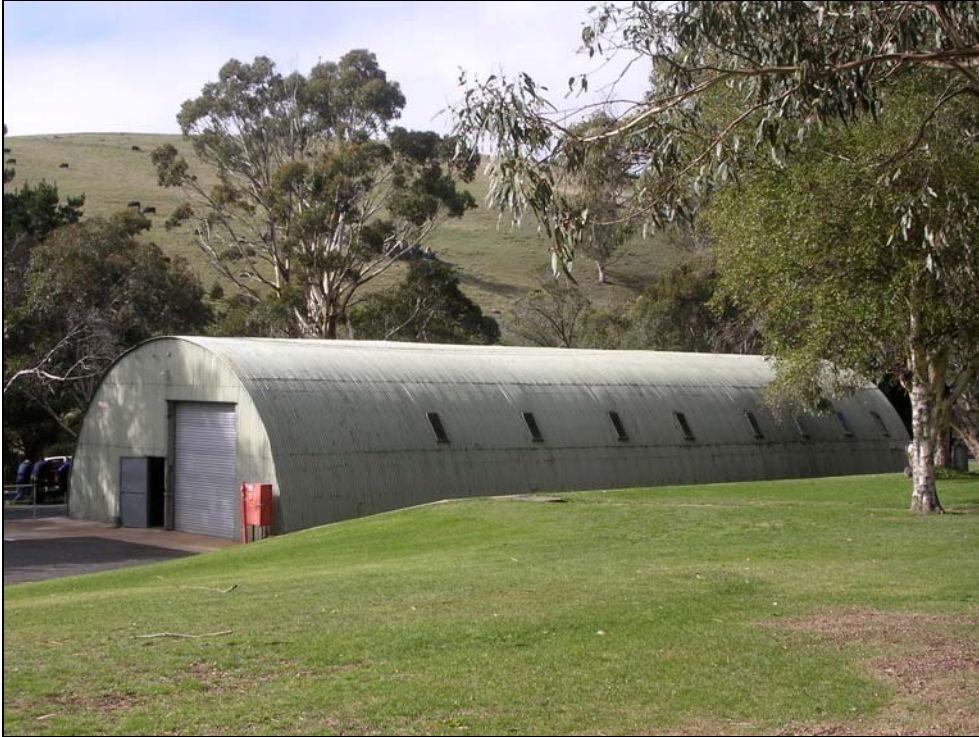
Plate 9: Pre-fabricated semi-cylindrical hut/workshop at Oberon Dam. View is from west.

A pre-fabricated semi-cylindrical hut/workshop is situated to the north of Oberon Dam, adjacent to the playground and BBQ facilities (**Figures 3–4**). The shed is currently used as a workshop (**Plate 10**) and is constructed of corrugated iron panels with an exterior painted light grey – green. The paintwork is generally in fair condition. Access at the northern end is via a roller door or a small access door. Access at the southern end is via hinged double corrugated iron/wooden doors.

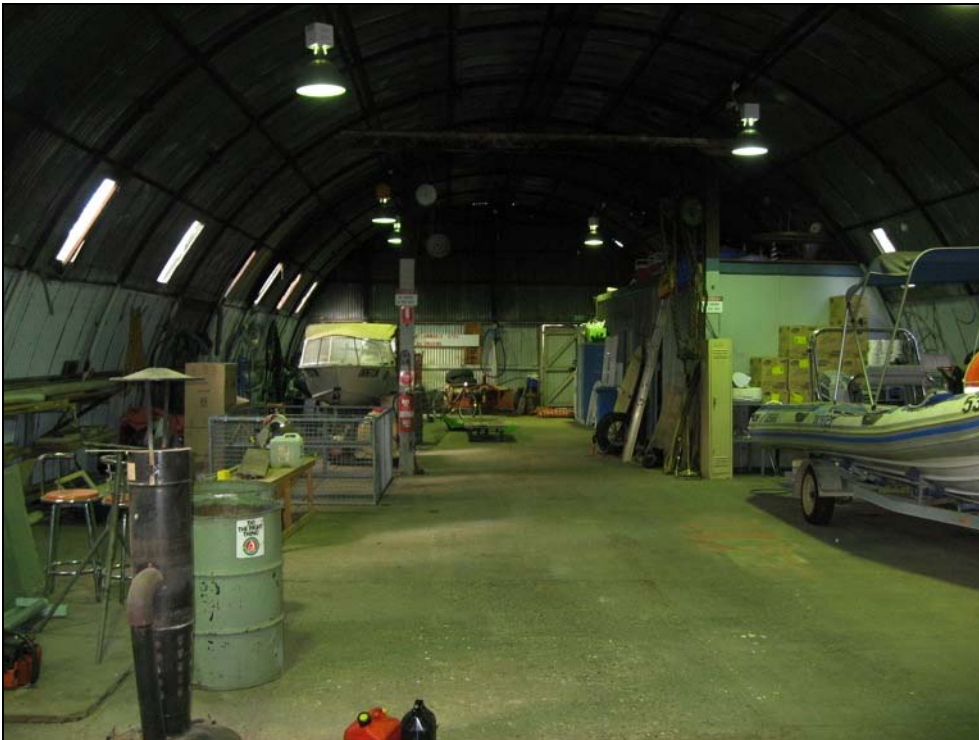
The interior of the shed is dry and well maintained and the original interior annex remains *in situ* (**Plate 10**). A number of the small windows (situated at approximately 3 m above ground height) are broken from outside the structure (**Plate 13**).

The overall condition of the pre-fabricated semi-cylindrical hut is good. The interior is dry and generally well-maintained (**Plate 10**) and the doors/locks are functional. Some windows are broken and the tin wall is dented in places, however, the shed remains in good working order and remains suited to its function (**Plates 12–13**). The building has seen a number of modifications, however, the overall function, structure, location, fabric and appearance have been retained.

Plate 10: Pre-fabricated semi-cylindrical hut/workshop at Oberon Dam, interior. View is from northern entrance.

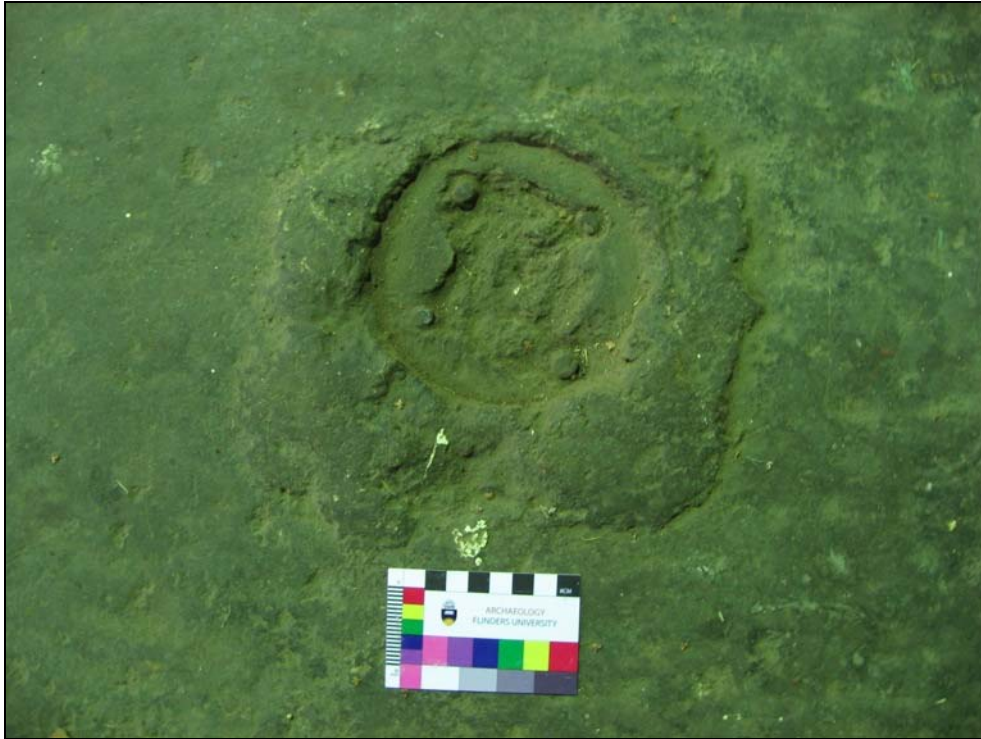
The shed's floor is concrete and bears evidence of fittings that have been removed (**Plate 11**). The building is approximately 27 m in length and approximately 10 m in width. 13 curved ribs support the structure, spaced at an average of 3 m. Minor damage exists to the ribs and other fittings, predominantly consisting of abrasions and rust (**Plate 12**). Towards the rear (southern) end of the shed stands the framework and working parts of a pulley and chain structure (**Plate 10**).

- A number of fittings, including plumbing, were removed prior to the late 1980s. Evidence exists on the shed floor of the locations of these fittings;
- The access doors at the northern end were replaced during the 1980/1990s by a roller door and one-person access door; and
- The exterior was repainted c. 1995.

Plate 11: Pre-fabricated semi-cylindrical hut/workshop at Oberon Dam, detail showing evidence of a removed floor fitting.

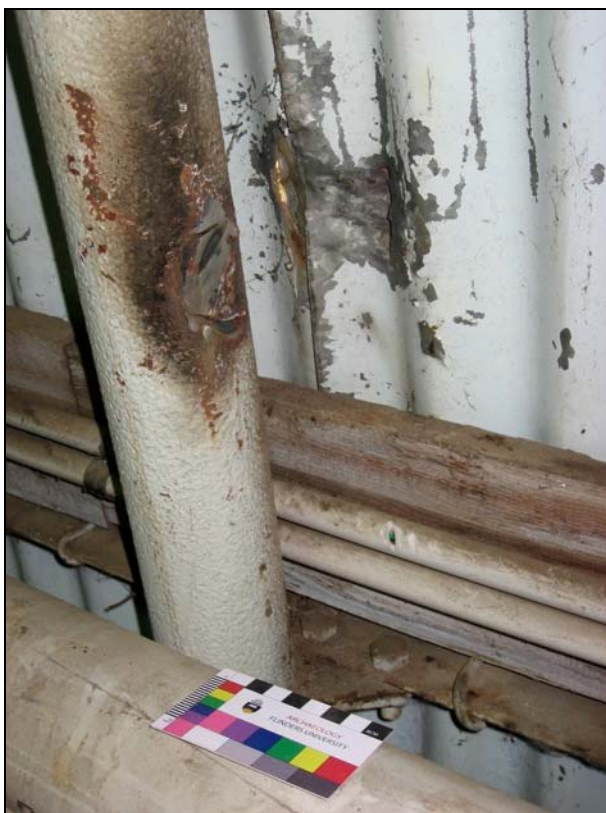
Plate 12: Pre-fabricated semi-cylindrical hut/workshop at Oberon Dam. Detail showing minor damage to lower part of rib.

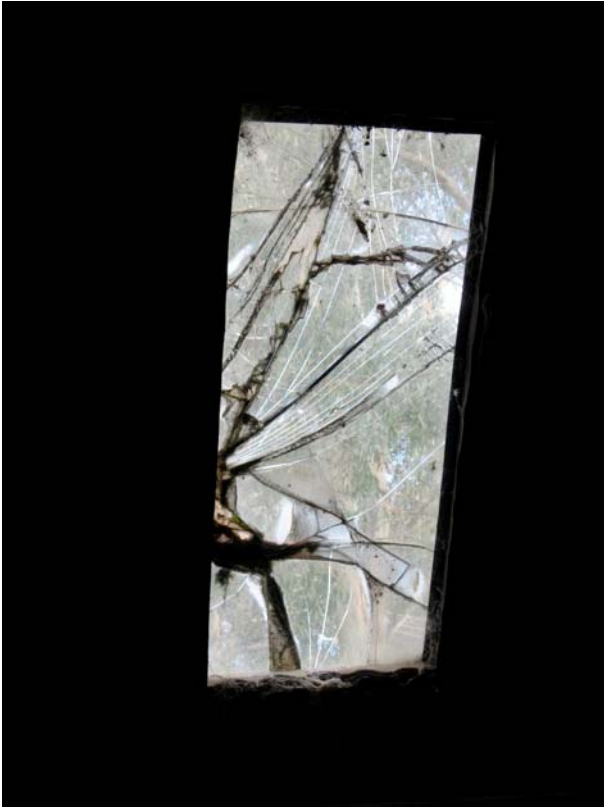
Plate 13: Pre-fabricated semi-cylindrical hut/workshop at Oberon Dam. Detail showing broken window. View is from inside building.

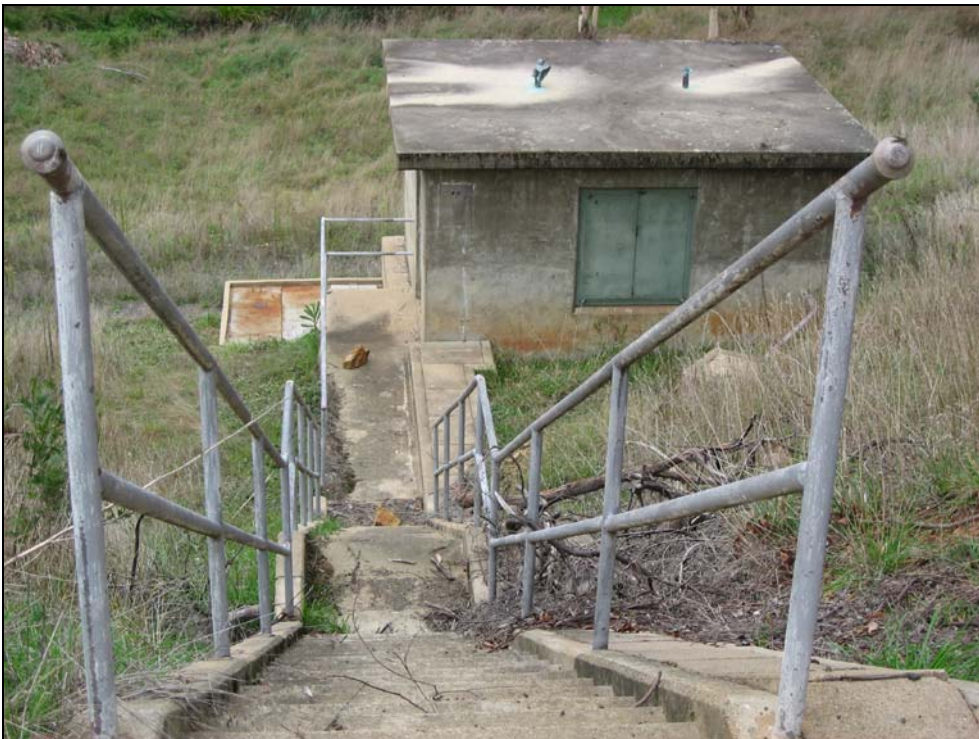
The Bailey valve hut is currently in fair condition (**Plate 14**). Its relative distance from the buttresses and difficulty of access has probably protected it from graffiti (unlike the old chlorinator hut and the buttresses). The hut no longer contains valve mechanisms, however, the exterior integrity of the building is high.

Plate 14: Bailey valve hut at Oberon Dam showing access steps. View is from west.

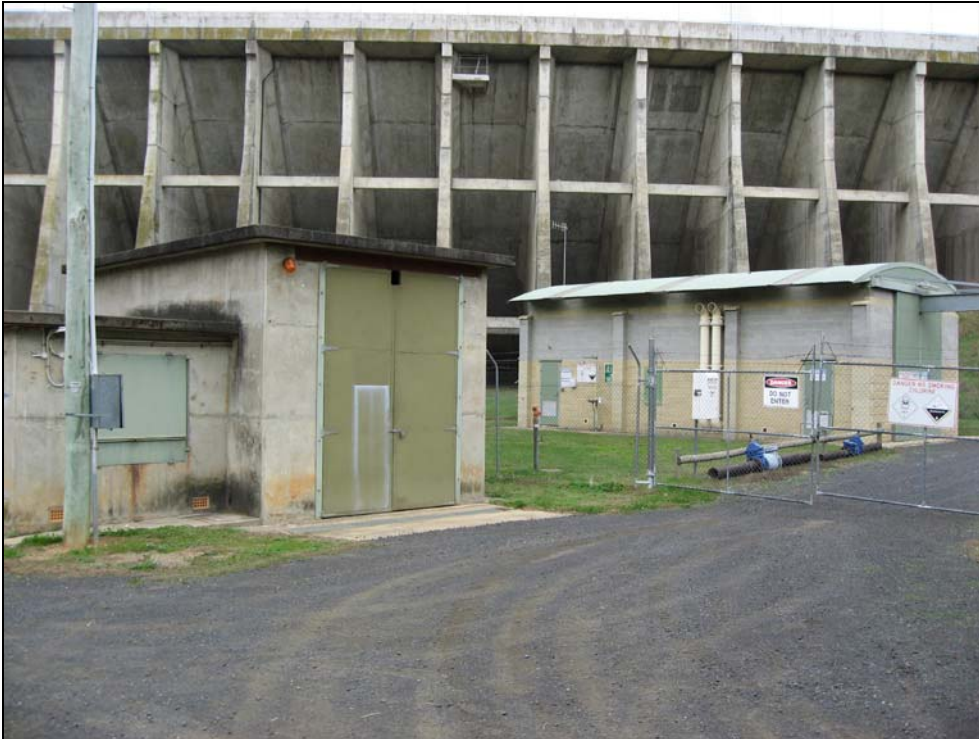
Plate 15: Disused chlorinator hut (left) and new chlorinator hut (right) at Oberon Dam (background). View is from north-west.

The old chlorinator hut is situated between the new chlorinator building and the old Bailey valve hut immediately forward of the Oberon Dam wall (**Figures 3–4** and **Plates 15–17**). The hut is of concrete construction and consists of two rectangular rooms. The building is accessed via a single-person door on the eastern side or via tall double doors on the northern side. Both the larger room and the small annex have flat roofs. The smaller annex has an outside window covered with a metal panel, hinged at the top. Two similar covered windows are situated on the western wall. The interior walls of the annex are partly tiled (black ceramic) (**Plate 16**). The southern walls contain spray painted graffiti (**Plate 17**).

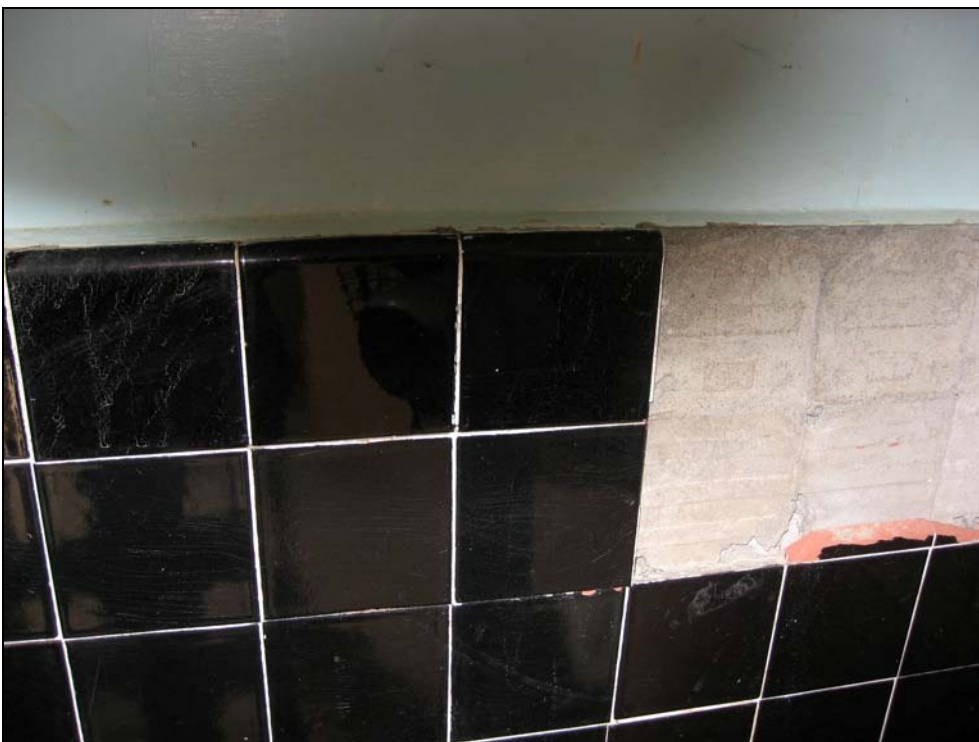
Plate 16: Disused chlorinator hut at Oberon Dam, detail of interior wall tiles.

The disused chlorinator hut is currently in fair condition. Graffiti on the southern walls testify to the building's current disuse (**Plate 17**), as the new chlorinator building is fenced and is therefore protected from graffiti. The exterior concrete walls are showing signs of discolouration, particularly near the base of the walls. The building's original fabric has largely been retained, however, its condition is deteriorating and its original function has been discontinued. Some internal wall tiles have been dislodged (**Plate 16**). No chlorination facilities are currently housed in the building.

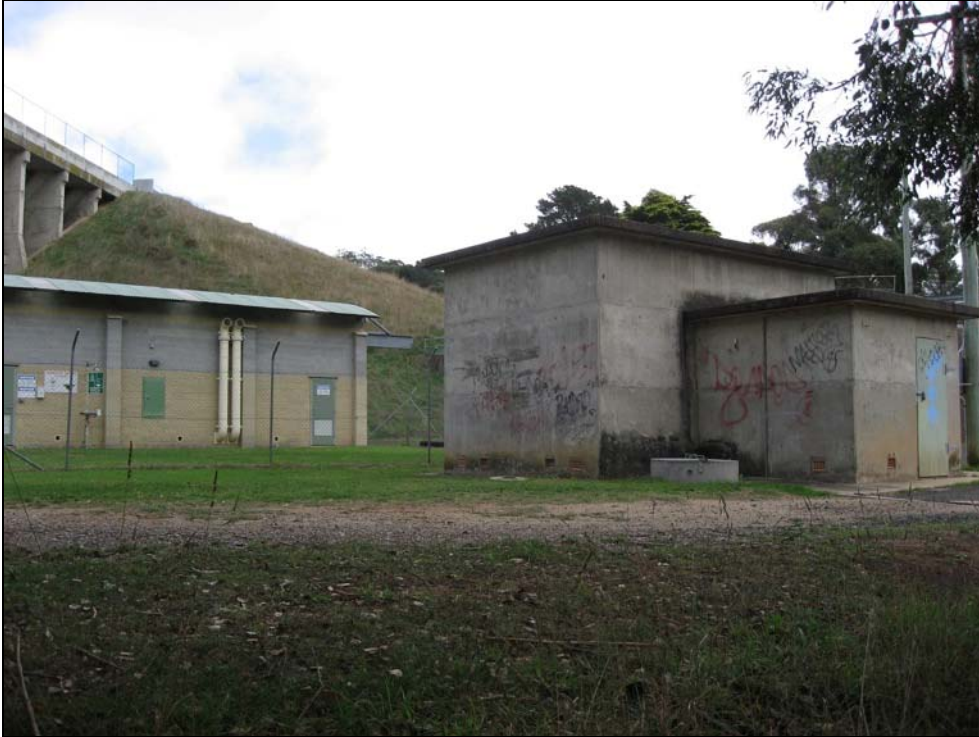
Plate 17: Disused chlorinator hut at Oberon Dam, showing wall graffiti. View is from south.

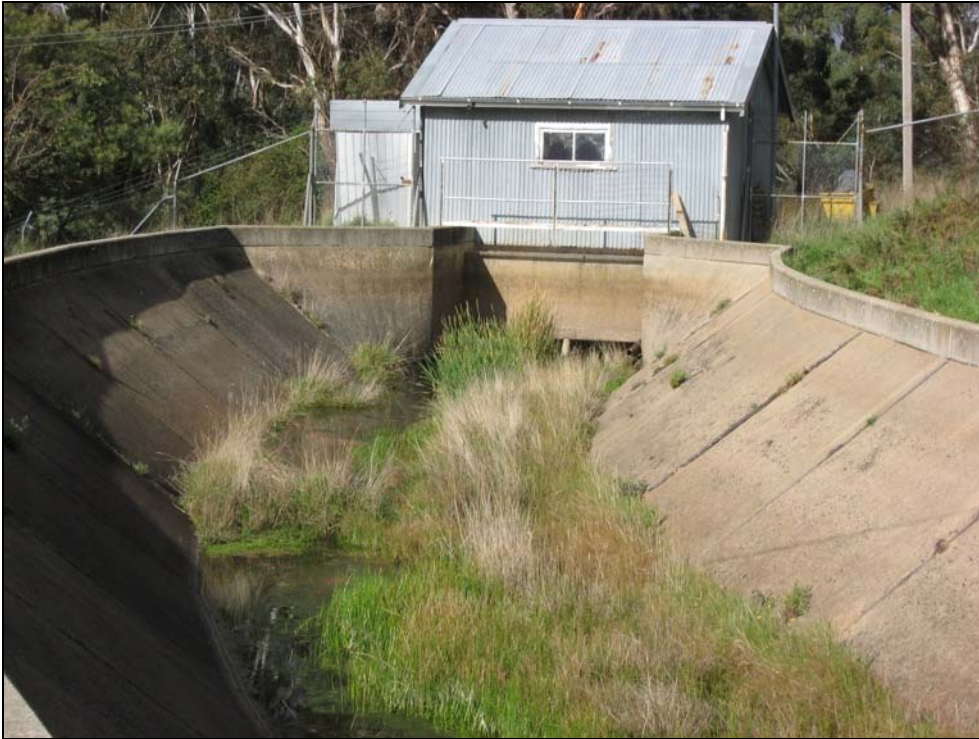
Plate 19: Break pressure tank at Duckmaloi showing concrete channel and eastern end valve hut. Note vegetation in channel. View is from centre of break pressure tank.

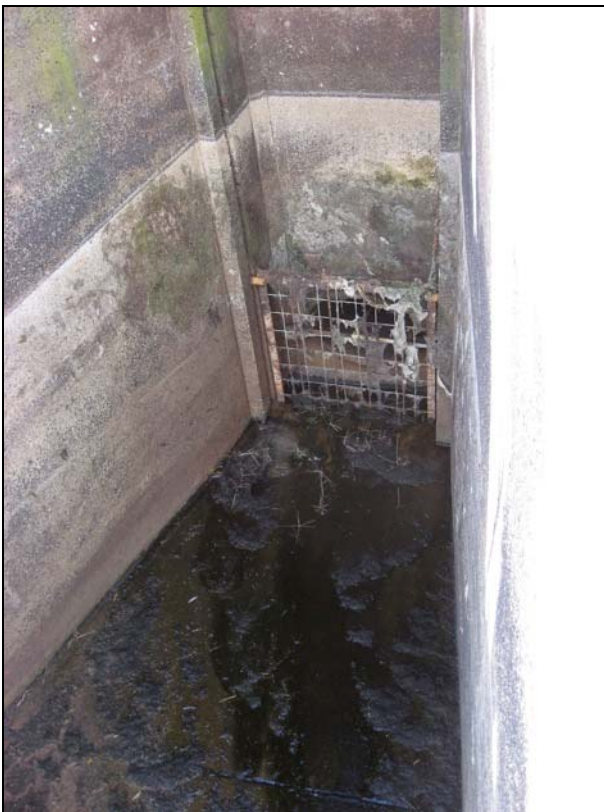
Plate 20: Break pressure tank at Duckmaloi showing central screening chamber outlet.

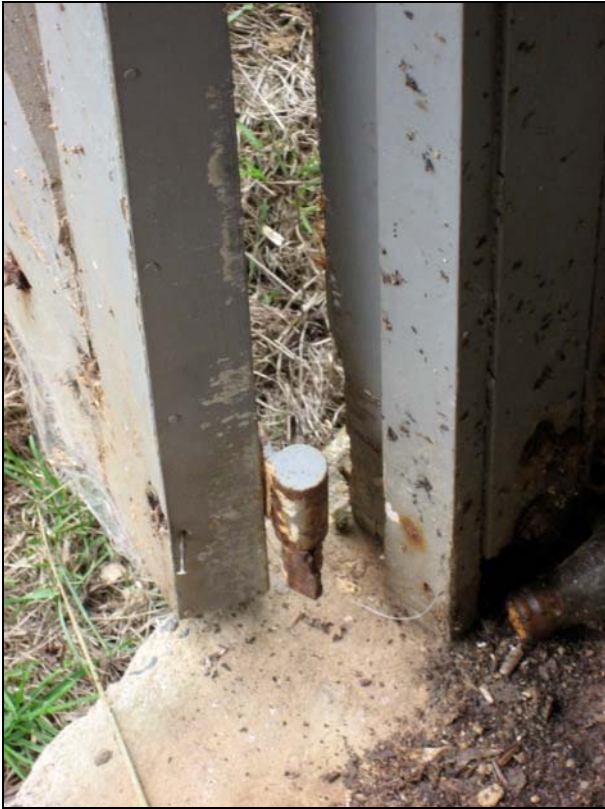
Plate 23: Hampton Tunnel inlet chamber. Detail of broken hinge.

As the FRWS continues to provide water to both major corporate and government customers, as well as individual consumers, it is vital that essential maintenance and upgrades continue. The component of the system requiring the most constant and urgent maintenance is the pipeline, a fact reflected in the high tempo of pipe work conducted immediately prior to and during the current study. Additionally, some buildings exist in a deteriorating state and currently require repairs (for example the door hinge at the Hampton Tunnel inlet).

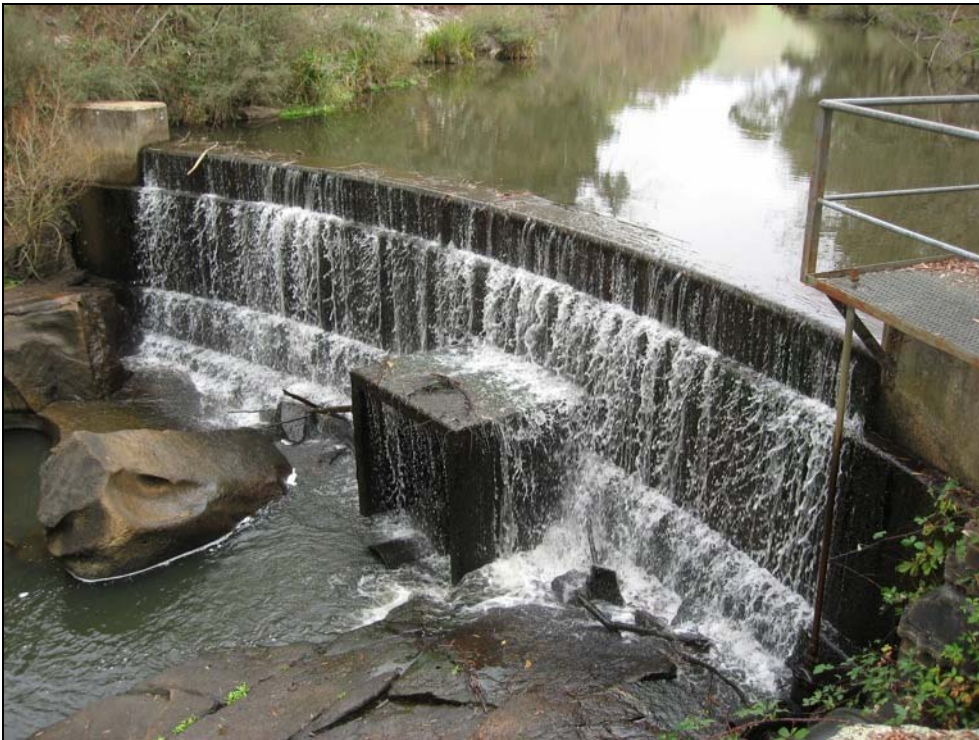
The weir is in good condition, both in terms of its fabric and functionality (**Plate 23**). The weir's original fabric has been retained and its past appearance and function remain intact.

Plate 23: Duckmaloi Weir showing intact dam wall.

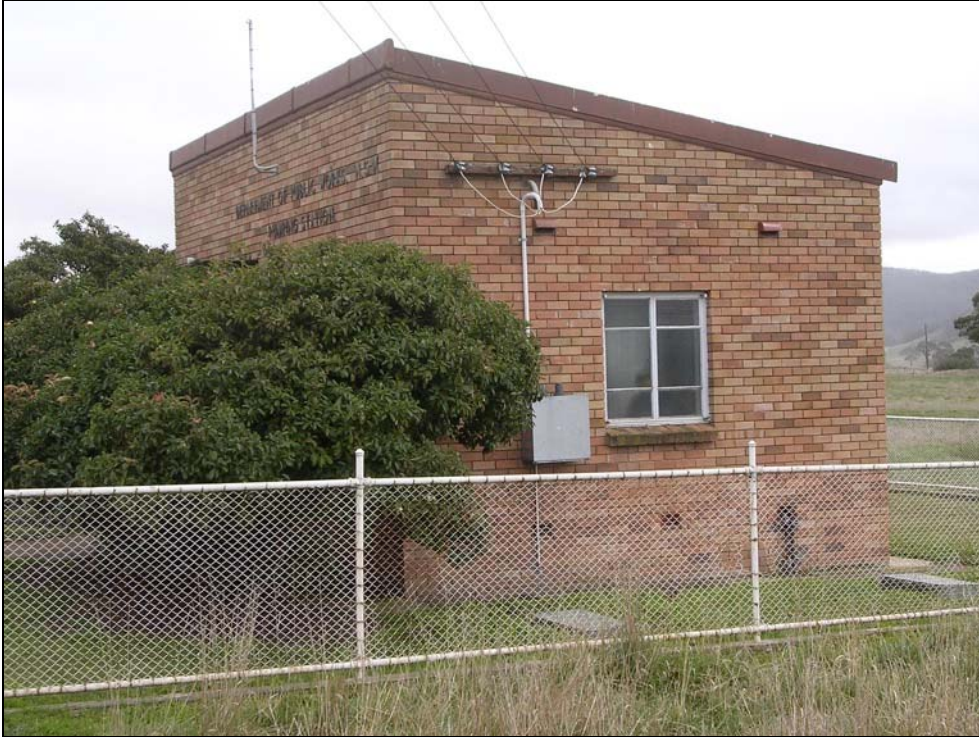
Plate 26: Wallerawang Pumping Station.

The building is well maintained and in good condition. The archaeological value of the building consists of the original signage (possibly the only remaining example of original DPW signage at any of the State Water FRWS assets – **Plate 26**) and the original pulley system, capable of lifting a maximum weight of 1.5 tons (**Plate 27**). The building's structure and fabric are largely intact and preserve its historical integrity. The original working parts of the building, however, were almost all

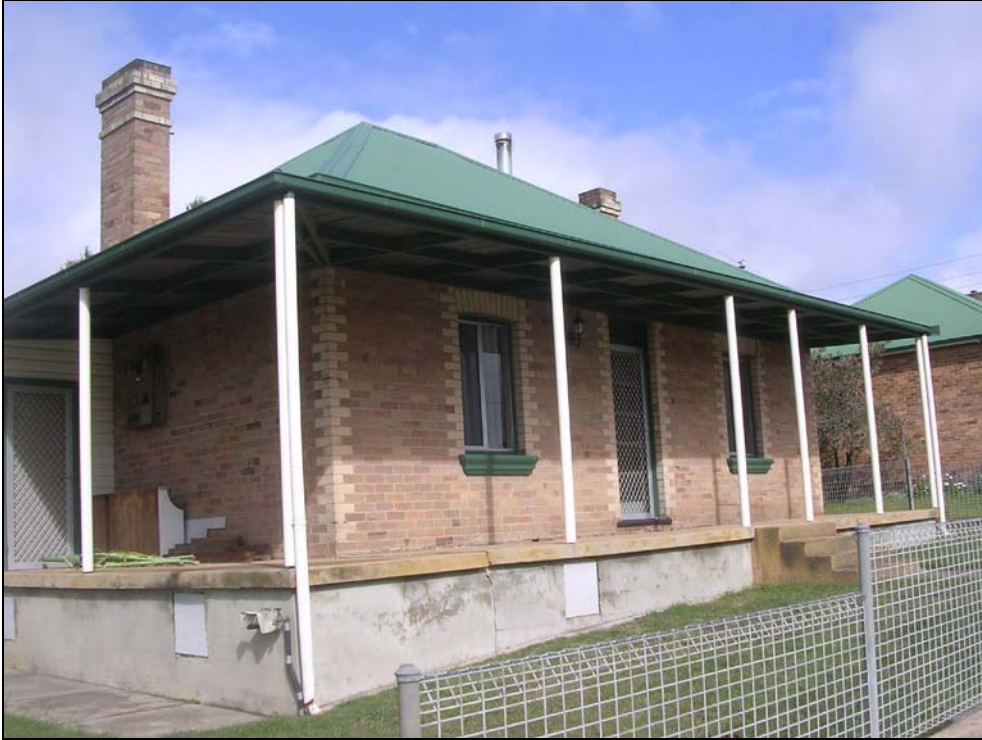
Plate 28: Wallerawang Depot, Inspector's house.

The house is a red brick building and consists of brick walls at the front of the house with weatherboard additions at the rear, a tin roof, concrete verandah and new windows/extensions (**Plate 28**). The house façade consists of a central door flanked by one window on each side. The roof is recent and constructed with mid to dark green corrugated metal (Colourbond). Whilst the house is over 50 years old, it underwent significant alterations following 1967. These alterations – including the more recent alterations such as the roof – are now as much a part of the fabric of the house as the original fabric.

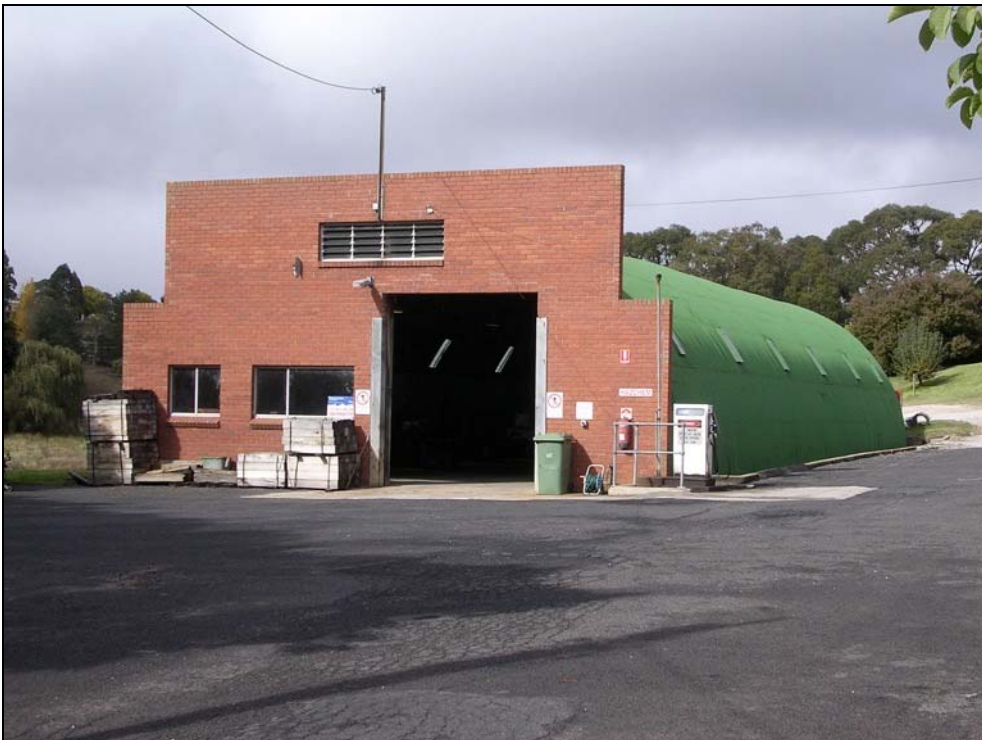
- The northern end saw the addition of a brick façade during the 1970/1980s. This façade retained the original window/door configuration but removed the original galvanised iron façade (**Plate 29**).
- The rear double doors have also been replaced with a roller door (post 1968) (**Plate 30**).

Plate 29: Wallerawang Depot, pre-fabricated semi-cylindrical hut/workshop, showing new façade. View is from north.

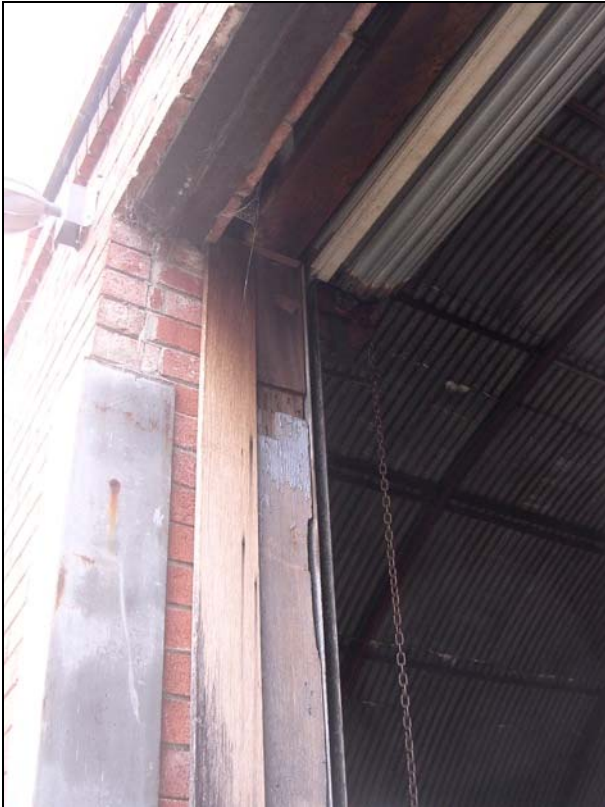
Plate 30: Wallerawang Depot, pre-fabricated semi-cylindrical hut/workshop, showing original door frame and brackets at rear of building.

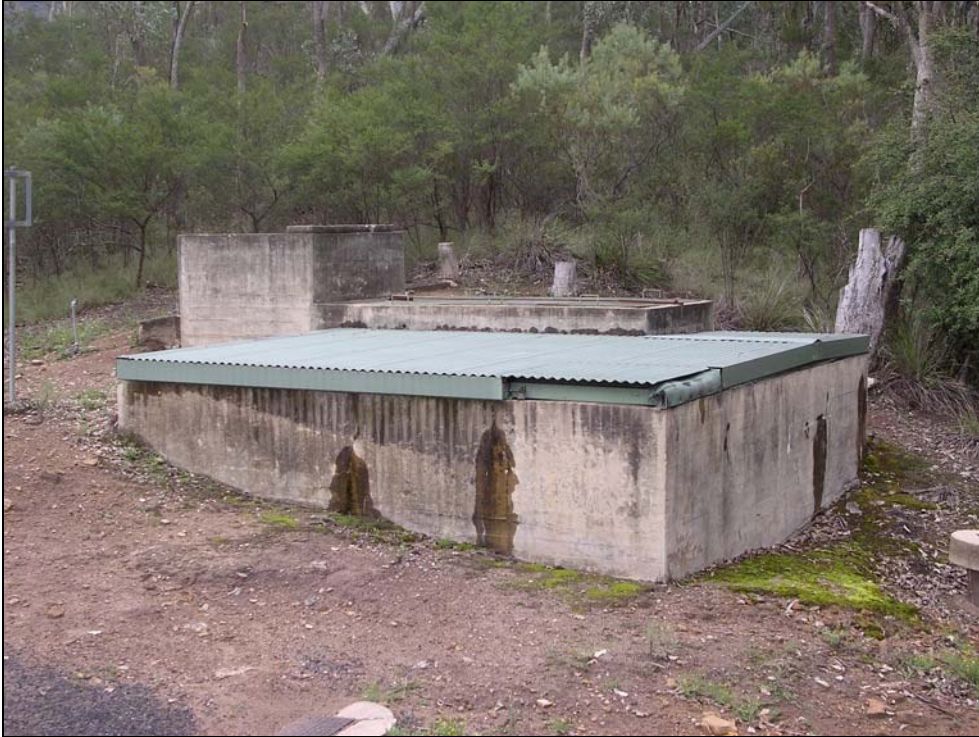
Whilst much of the original fabric of the reservoir complex is intact, the new roofing is a significant alteration. The discolouration of the pup tank concrete indicates that the condition of its original fabric is deteriorating.

The pup tank in fair condition and shows significant concrete discolouration (**Plate 32**).

Plate 32: Glen Davis pup tank. View is from west.

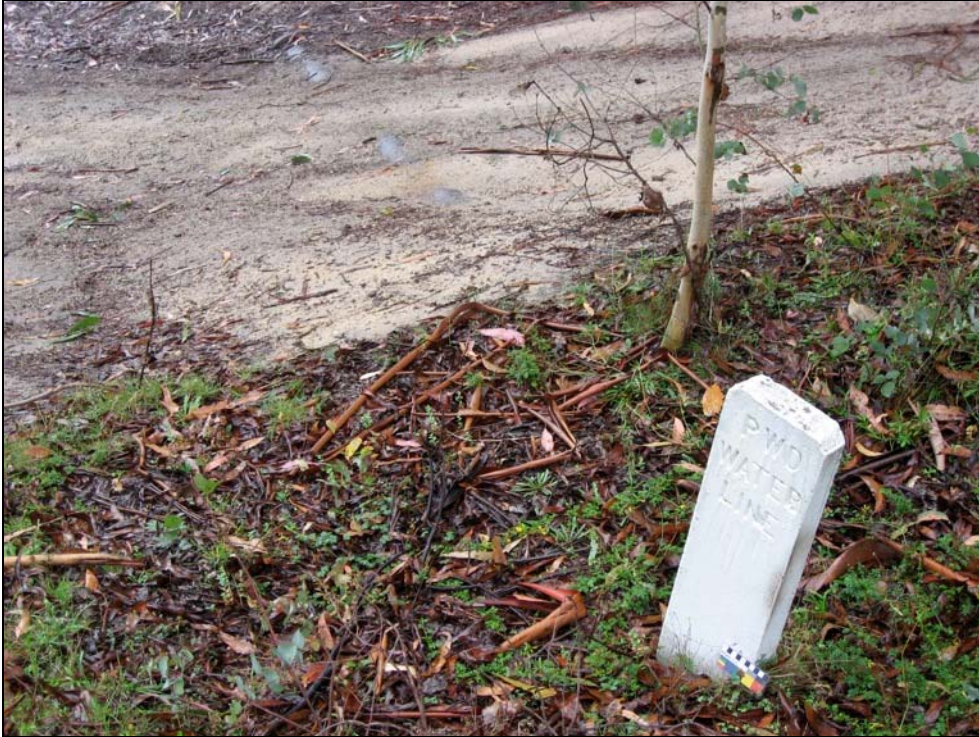
Pipeline conditions vary throughout the Study Area. During the week of the current survey, numerous pipeline leaks and bursts had occurred and State Water employees had been engaged in repairs for a number of days prior to the survey. In general, newer sections of pipe remain in good condition whilst older sections are deteriorating.

Plate 34: FRWS pipeline in the vicinity of Baal Bone Gap. Shows above ground marker and exposed pipe.

- If sections of Stage One or Stage Two pipelines need to be replaced, the existing steel/concrete pipe should be left in place where possible; and
 - If assets identified in this report as holding heritage significance need to be replaced or substantially altered, the present structures should be the focus of a detailed assessment and recorded to archive quality: if it is not possible to leave them in place.

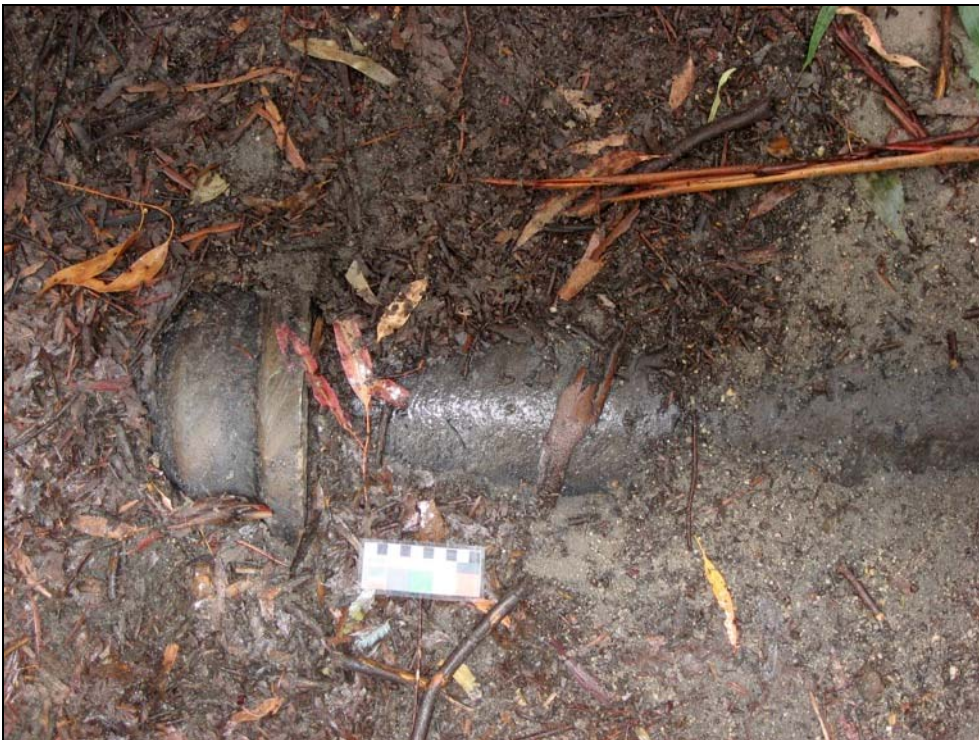
Plate 35: FRWS pipeline in the vicinity of Baal Bone Gap. Detail of exposed pipe.
